Repair of RC Elements Partially Damaged by Explosions

This research aims to investigate the effect of using cement grout and epoxy compound in repairing reinforced concrete elements partially damaged by explosions. The research methodology goes through two steps. In the first step, six samples of reinforced concrete slabs are prepared for the laboratory tests. Citorex grout and kema epoxy 103 are used to repair the damage concrete. Tests to measure the deflection and strain due to the maximum load before and after the repair process are carried out. In the second step, four reinforced concrete samples were exposed to a direct explosive force produced by the detonation of 250 grams of TNT, and the effects resulting from the explosion were observed. After that, the repair process was carried out for these samples. Then these samples were exposed again to a second blast force from 250 grams of TNT, and the effects resulting from the explosion were observed.

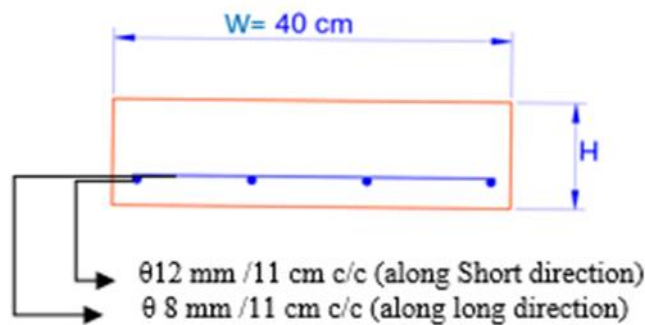
Figure 1: Typical steel reinforcement of slabs

Figure 1 depicts the typical steel reinforcement used in the tested slabs, providing a visual representation of the reinforcement pattern. On the other hand, Figure 2 showcases the slabs under load conditions at the mid span. In this figure, the strain gauge and steel wire are positioned at the mid span of the tested sample, allowing for the measurement and monitoring of strain and stress levels during the experiment.

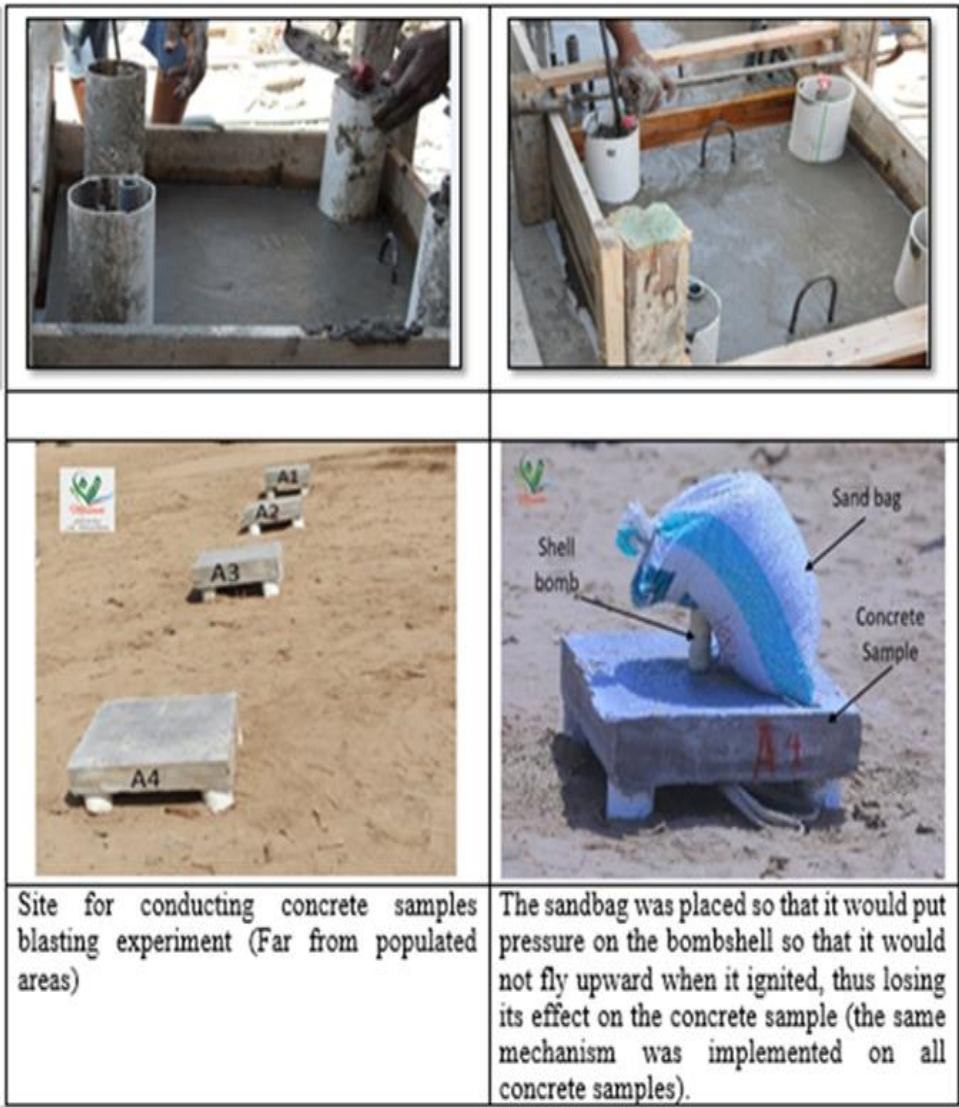
Figure 3: The four concrete samples during casting at site

explosive force generated by detonating 250 grams of TNT. The resulting effects of the explosion were observed and studied. Figure 3 displays the four concrete samples during the casting process at the site [21].

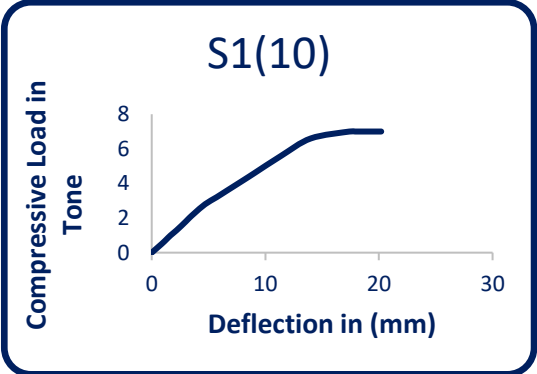
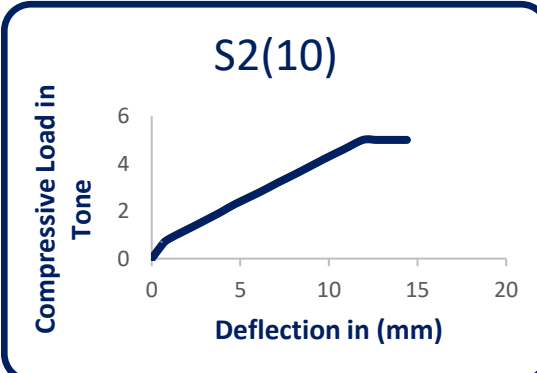
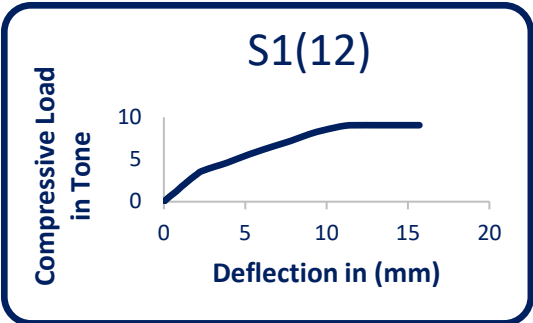
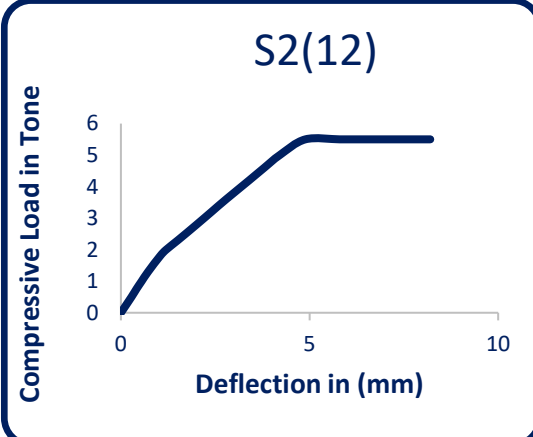
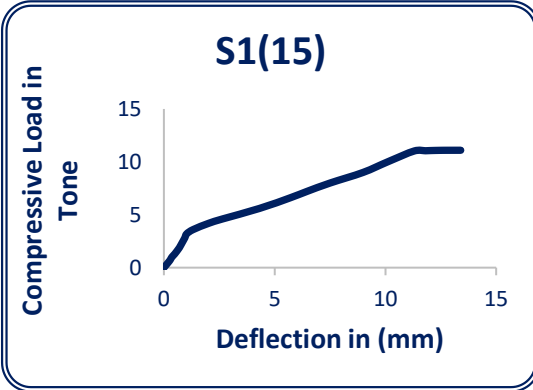
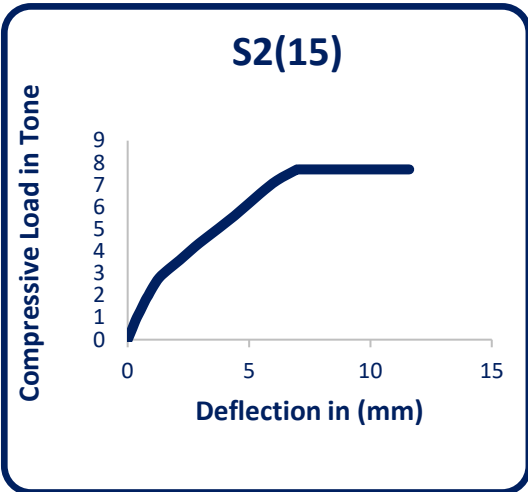
Figure 5: The load-deflection curve for the concrete sample S1 (10) before repair	Figure 11 : The load-strain curve for the concrete sample S1 (10) before repair

Figure 6: The load-deflection curve for the concrete sample S2 (10) before repair	Figure 12 : The load-strain curve for the concrete sample S2 (10) before repair

</div> <p>Figure 7: The load-deflection curve for the concrete sample S1 (12) before repair</p>	<div><p>S1(12)</p>

</div> <p>Figure 8: The load-deflection curve for the concrete sample S2 (12) before repair</p>	<div><p>S2(12)</p>

</div> <p>Figure 9: The load-deflection curve for the concrete sample S1 (15) before repair</p>	<div><p>S1(15)</p>

Figure 10: The load-deflection curve for the concrete sample S2 (15) before repair	Figure 16 : The load-strain curve for the concrete sample S2 (15) before repair

Figures 5 to 10 display the load-deflection curves for the concrete slab samples S1 (10), S2 (10), S1 (12), S2 (12), S1 (15), and S2 (15) before undergoing repairs. These curves illustrate

the relationship between the applied load and the resulting deflection of the slabs. Additionally, Figures 11 to 16 present the load-strain curves for the same concrete slab samples. These curves depict the relationship between the applied load and the corresponding strain in the slabs before any repairs were made.

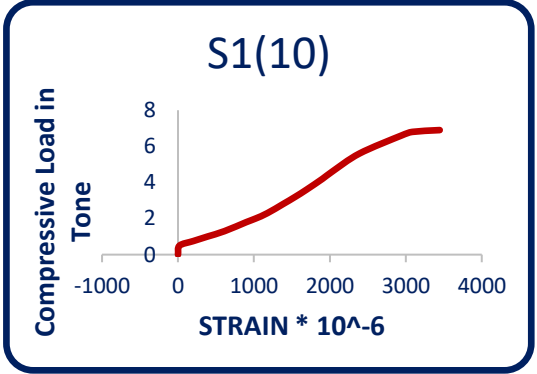
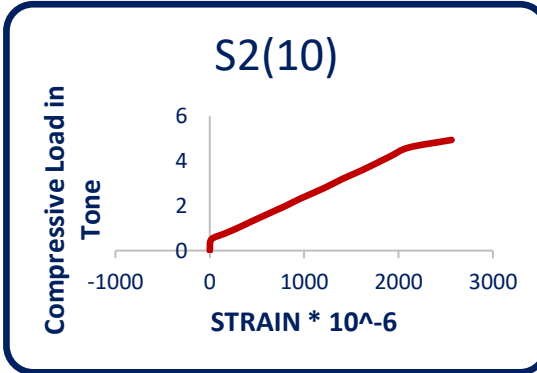
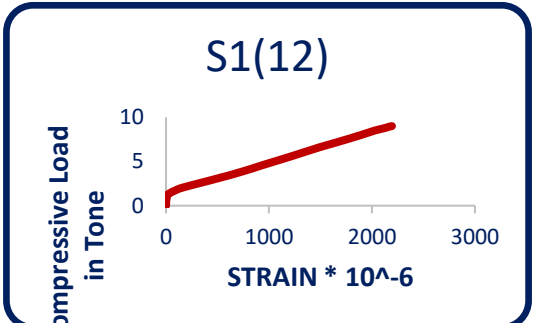
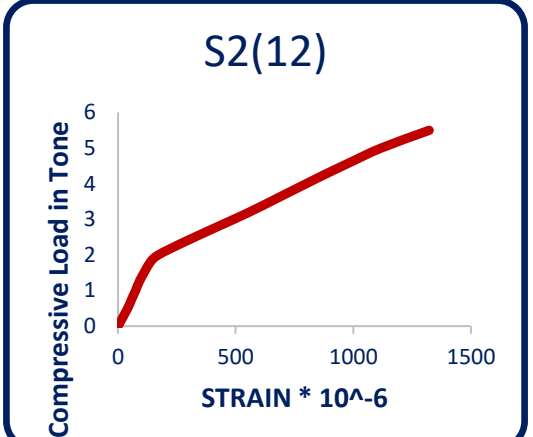
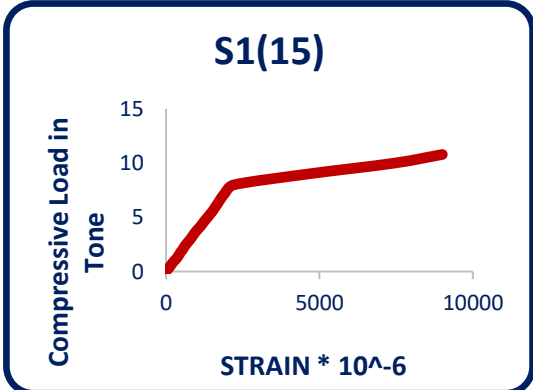
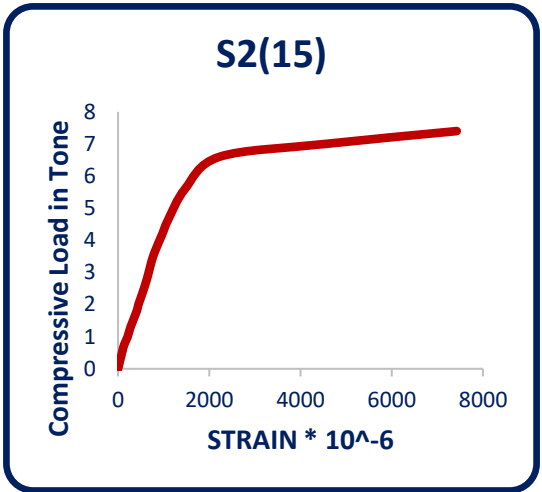
</div> <p>Figure 13 : The load-strain curve for the concrete sample S1 (12) before repair</p>
<div><p>S2(12)</p>

</div> <p>Figure 14 : The load-strain curve for the concrete sample S2 (12) before repair</p>
<div><p>S1(15)</p>

</div> <p>Figure 15 : The load-strain curve for the concrete sample S1 (15) before repair</p>

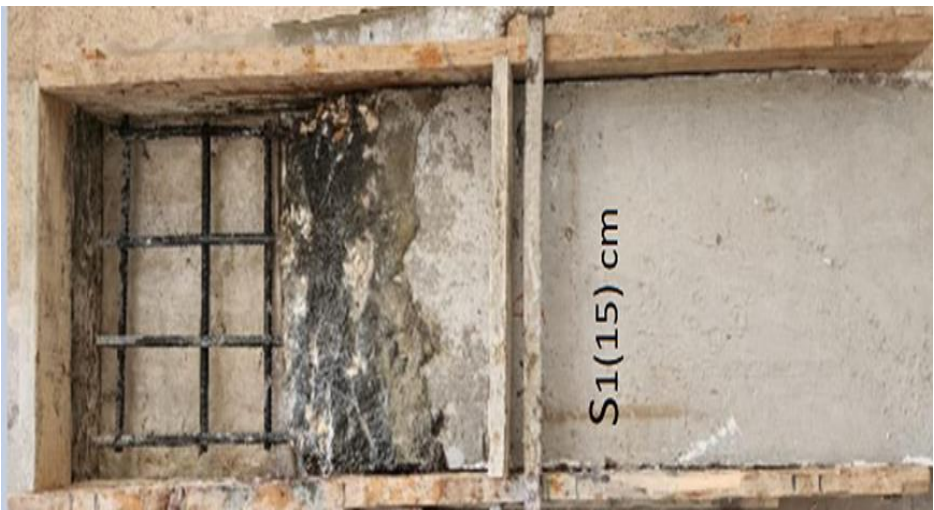
Figure 17: Repair of the control samples S1(10), S1(12) & S1(15) by using Citorex grout

The control slab samples, namely S1 (10), S1 (12), and S1 (15), underwent the same treatment process for repair. This involved removing the damaged parts of the slabs. Subsequently, a concrete mixture reinforced with Citorex Grout was applied as shown in Figure 4.17, presumably as a repair material.

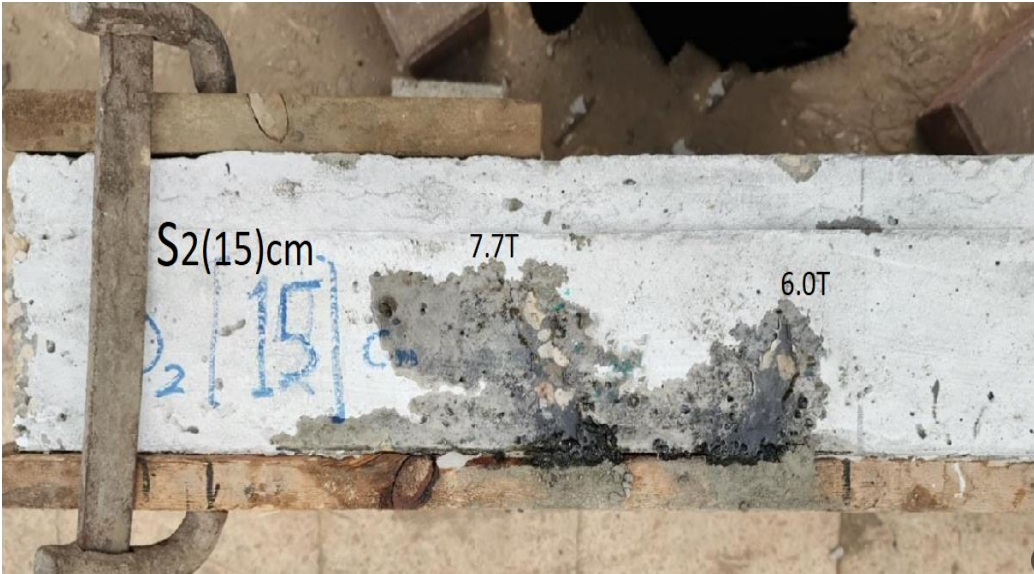
Figure 18: Repair of the concrete samples S2(10), S2(12) & S2(15) using Kema Epoxy 103

The other reinforced concrete slab samples, namely S2 (10), S2 (12), and S2 (15), underwent a similar treatment approach for repair. This involved slightly enlarging the cracks in the concrete. Subsequently, Kema Epoxy 103, a substance used for repair purposes, was applied using the injection method. The epoxy was left to harden, as depicted in Figure 18, in order to secure and strengthen the repaired areas of the concrete samples.

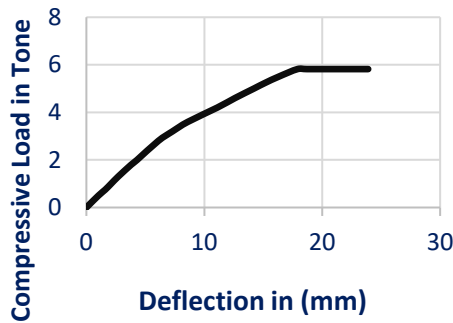
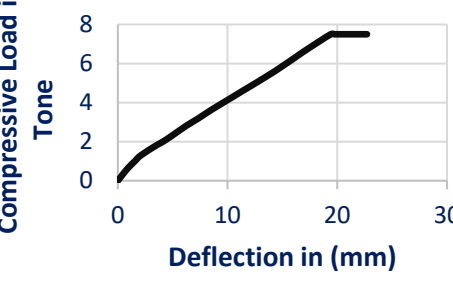
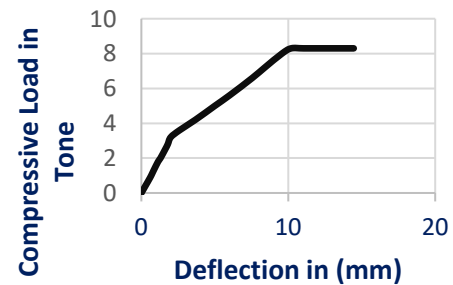
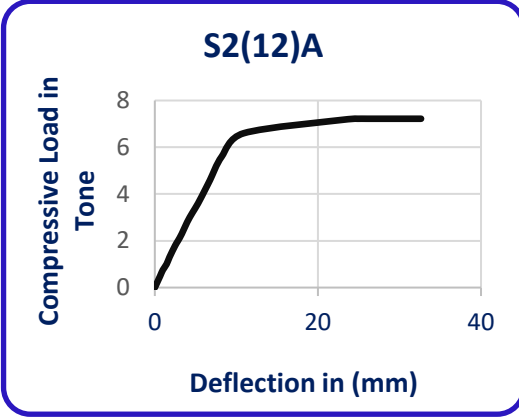
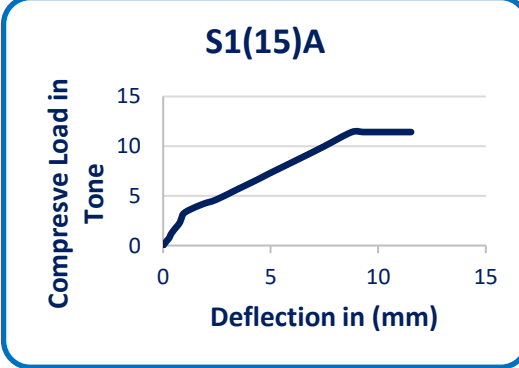
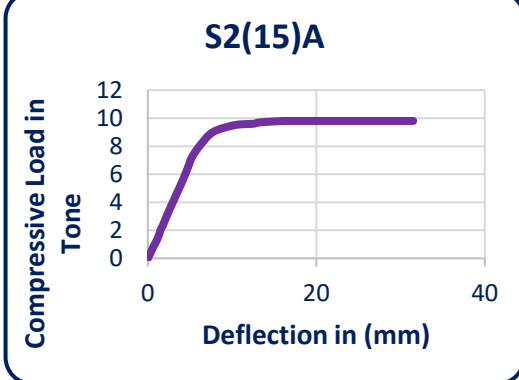
</div> <div>Figure 19 : The load-deflection curve for the concrete sample S1 (10)A after repair</div>	<div><p>S1(10)A</p>

</div> <div>Figure 20 : The load-deflection curve for the concrete sample S2 (10)A after repair</div>	<div><p>S2(10)A</p>

</div> <div>Figure 21 : The load-deflection curve for the concrete sample S1 (12)A after repair</div>	<div><p>S1(12)A</p>

</div> <div>Figure 22 : The load-deflection curve for the concrete sample S2 (12)A after repair</div>	<div><p>S2(12)A</p>

</div> <div>Figure 23 : The load-deflection curve for the concrete sample S1 (15)A after repair</div>	<div><p>S1(15)A</p>

</div> <div>Figure 24 : The load-deflection curve for the concrete sample S2 (15)A after repair</div>	<div><p>S2(15)A</p>

Figures 19 to 24 depict the load-deflection curves for the concrete samples S1 (10), S2 (10), S1 (12), S2 (12), S1 (15), and S2 (15) after the repair process. These curves illustrate the relationship between the applied load and the resulting deflection of the repaired concrete samples. Moreover, Figures 25 to 30 present the load-strain curves for the same concrete samples after the repair. These curves illustrate the relationship between the applied load and

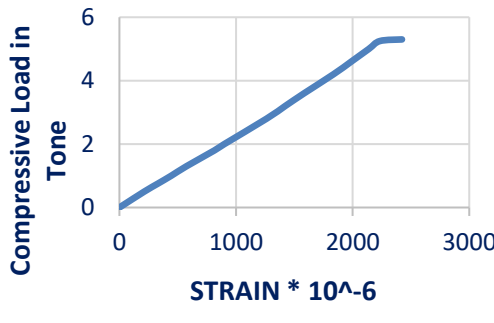
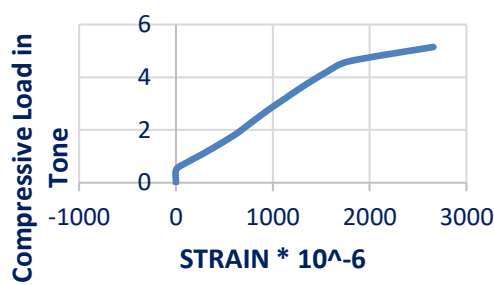
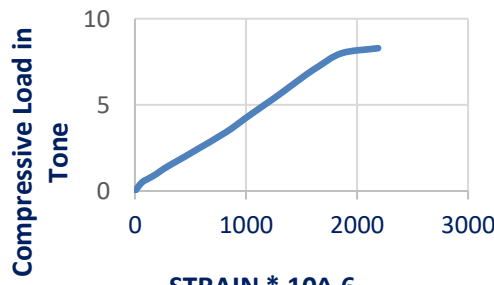
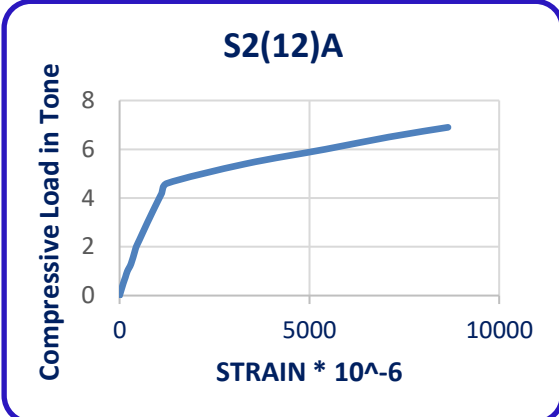
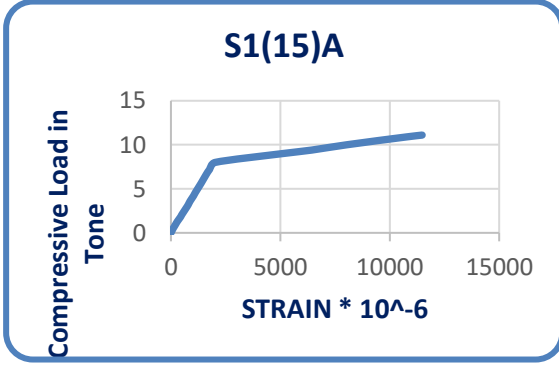
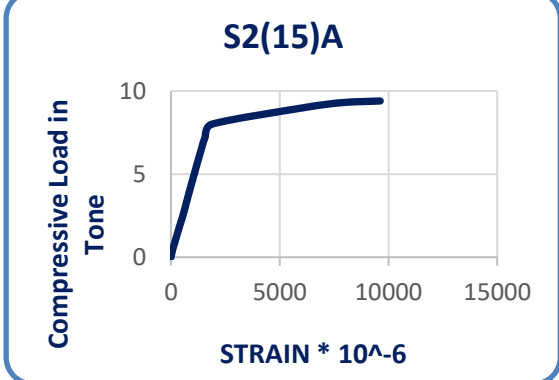
</div> <div>Figure 25 : The load-strain curve for the concrete sample S1 (10)A after repair</div>
<div><p>S2(10)A</p>

</div> <div>Figure 26 : The load-strain curve for the concrete sample S2 (10)A after repair</div>
<div><p>S1(12)A</p>

</div> <div>Figure 27 : The load-strain curve for the concrete sample S1 (12)A after repair</div>

</div> <div>Figure 28 : The load-strain curve for the concrete sample S2 (12)A after repair</div>
<div><p>S1(15)A</p>

</div> <div>Figure 29 : The load-strain curve for the concrete sample S1 (15)A after repair</div>
<div><p>S2(15)A</p>

</div> <div>Figure 30 : The load-strain curve for the concrete sample S2 (15)A after repair</div>

the corresponding strain in the concrete samples following the repair process.

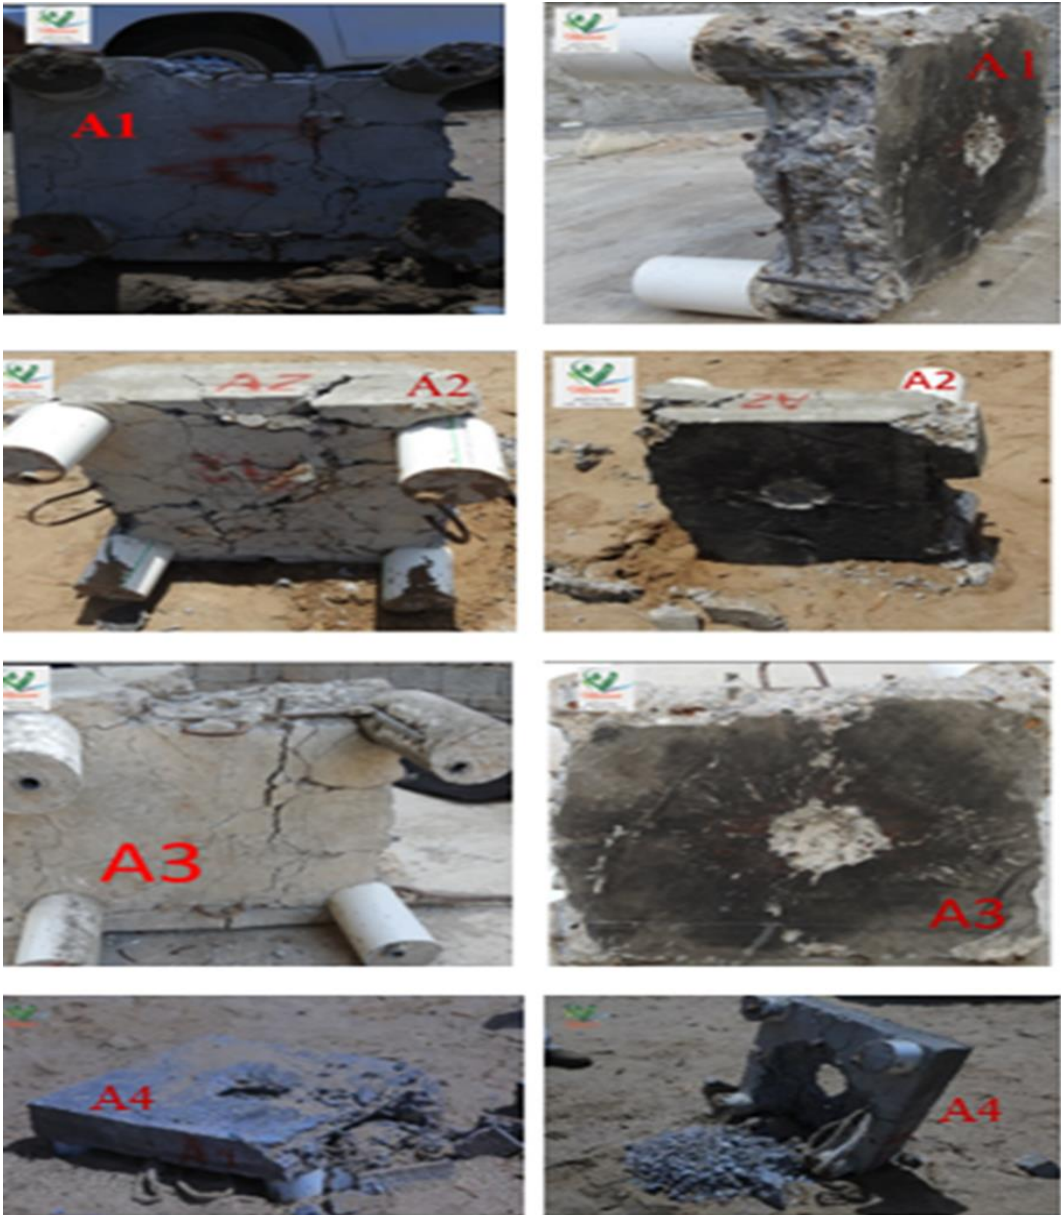
Figure 34: The damage of the concrete samples after being exposed to the first blast

Figure 34 shows the damage of the concrete samples after being exposed to the first blast.

The results of the experiment show that, except for the 10 cm thick concrete sample which shattered during the first blast, the remaining samples demonstrated improved resistance to the second blast. Additionally, the findings indicate that concrete elements with greater thickness exhibit better resistance to blast loads compared to concrete elements with reduced thickness.

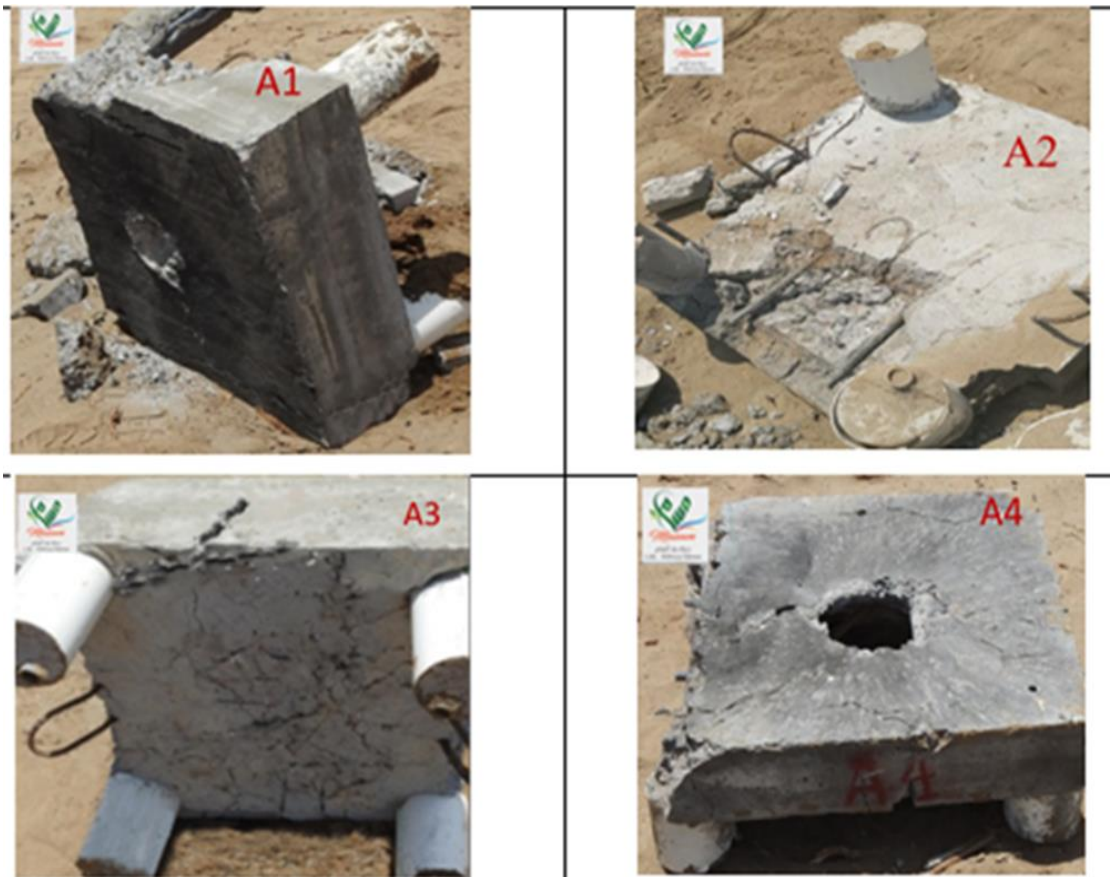
Figure 35: The damage of the concrete samples after being repaired and exposed to a second blast

Figure 35 shows the damage of the concrete samples after being repaired and exposed to a second blast.
