Analysis of the Bolt Inclination Angle Using Digital Image Correlation (New Optical Method)

Faci Youcef¹, Djillali Allou¹, Mebtouche Ahmed²

¹Research Center in Industrial Technologies (CRTI), BP 64, Route Dely Brahim, Cheraga, Algiers, Algeria

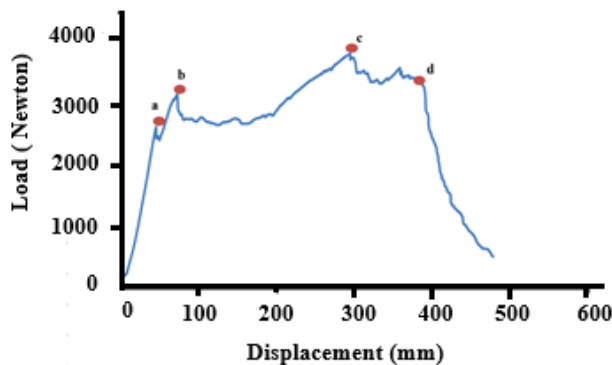
Fig. 3 Typical curve of load versus time of group S1 accompanied with C.C.D camera.

Typical bearing load versus time curves for the single-lap fastened joints S1, S2, and S3 are presented in Figs. 3, 4, and 5, respectively. A Charge-Coupled Device (CCD) camera monitored the progressive damage until failure.

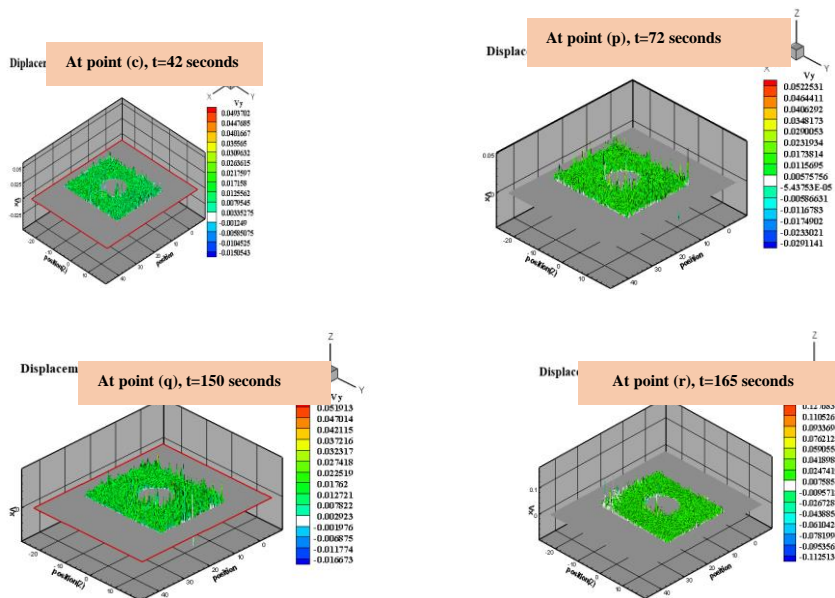
Fig. 9 Axial displacement V_y of the specimen during the tensile test [mm]

The load drop observed after reaching the ultimate load, associated with excessive strain concentration at point “q”, demonstrates the typical behavior of composite materials under tensile loading. This drop indicates that the specimen has exceeded its capacity to carry a load,

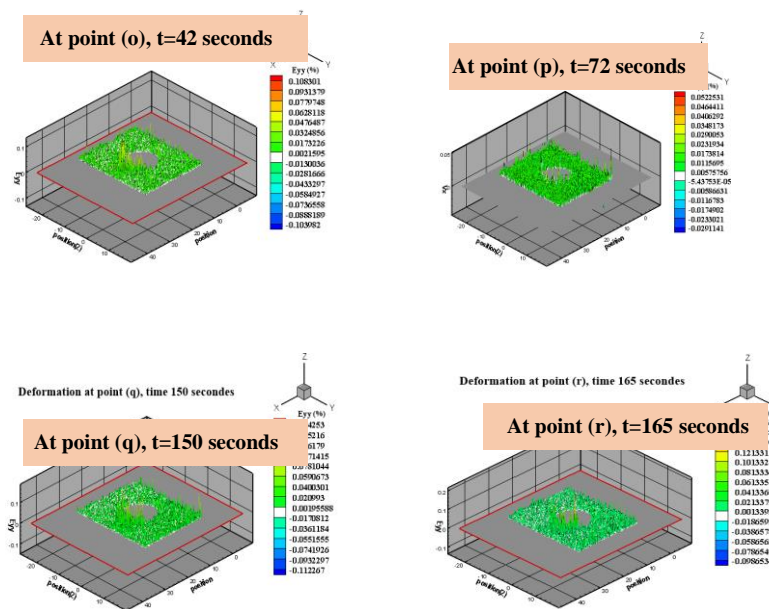
Fig. 10 Axial Strain E_{yy} % of the specimen during the tensile

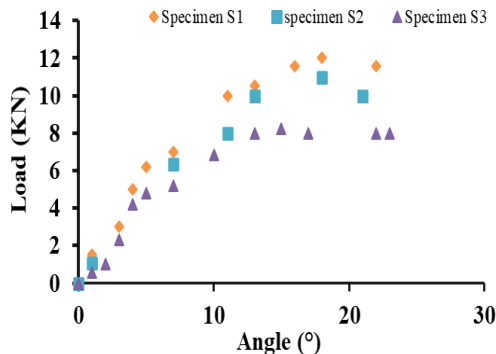
Fig. 12 Load versus angle bolt inclination for a typical specimen S1, S2, and S3 during tensile test.

The evolution of bolt inclination angle in the side view of the bolt throughout the experiment test of composite is shown in Fig. 11 accompanied by the matrix cracking at point “o”, decohesions fiber/matrix at point “p”, delaminate at point “q”, and final failure fiber at point “r”. Load versus angle bolt inclination for typical curves of group S1, S2 and S3 tensile test is presented in Fig. 12. The inclination angle typically changes, reflecting how the specimen responds under stress. Different zones of failure will exhibit varying responses to load, affecting the angle of inclination. At point “o”, Matrix cracking begins at lower loads, with the inclination angle potentially responding more sensitively at this stage due to local stress concentrations. At point “p”, fiber-matrix decohesion involves the interface between fibers and the matrix and may show different inclination angles of as the load approaches higher levels. The inclination angle in the zone of delamination at point “q”, can be significantly influenced by the stacking sequence. Delamination might lead to a pronounced change in torque and load-handling capacity. The final failure at point “r” may present a steep change in the inclination angle, indicative of the fastened joint reaching its load limit [10-12].
